Assessment of Dam Safety

Coal Combustion Surface Impoundments (Task 3)

Final Report

JM Stuart Station

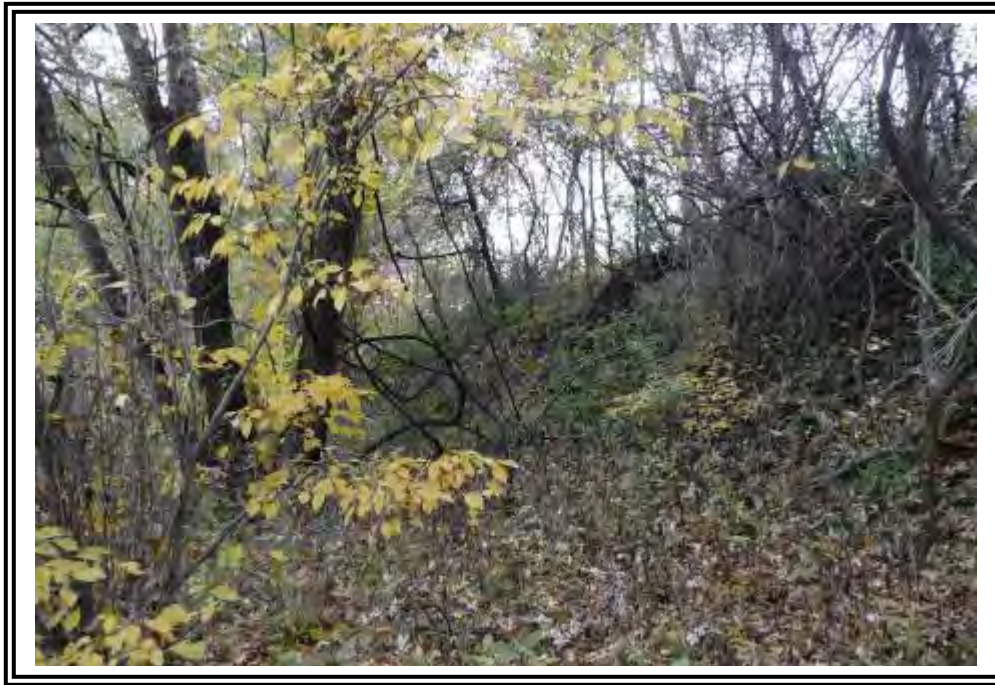
91

Another view of larger trees at the toe of the downstream slope of Pond 7 near the Ohio River bank.

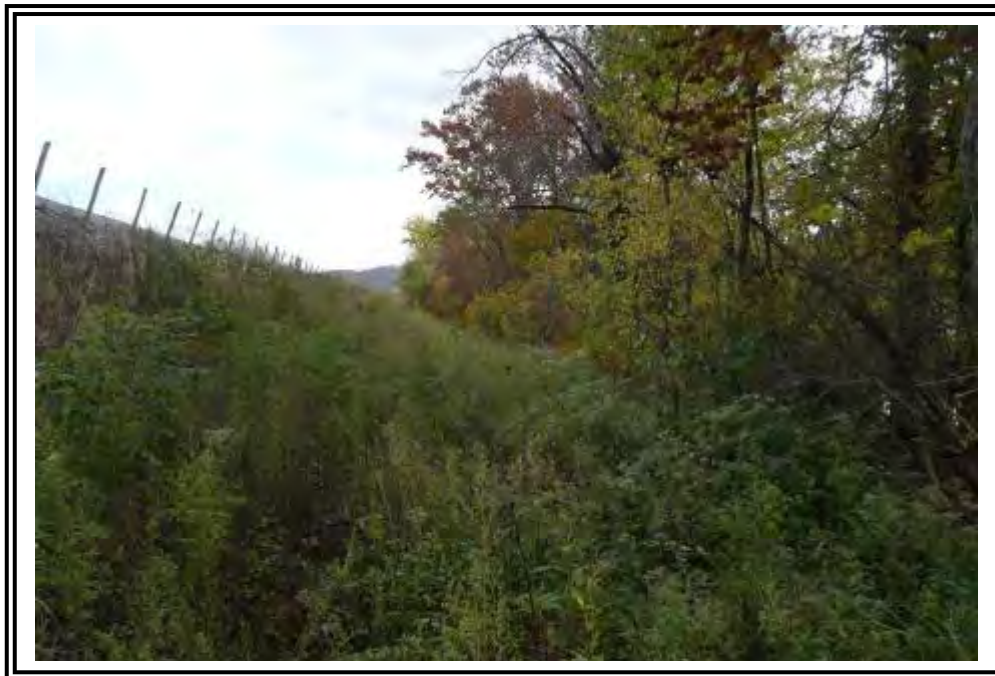
92

Looking east along the downstream slope of the Pond 7 south dike near the Ohio River bank.
Note heavier woody vegetation and trees encroaching on dike toe.

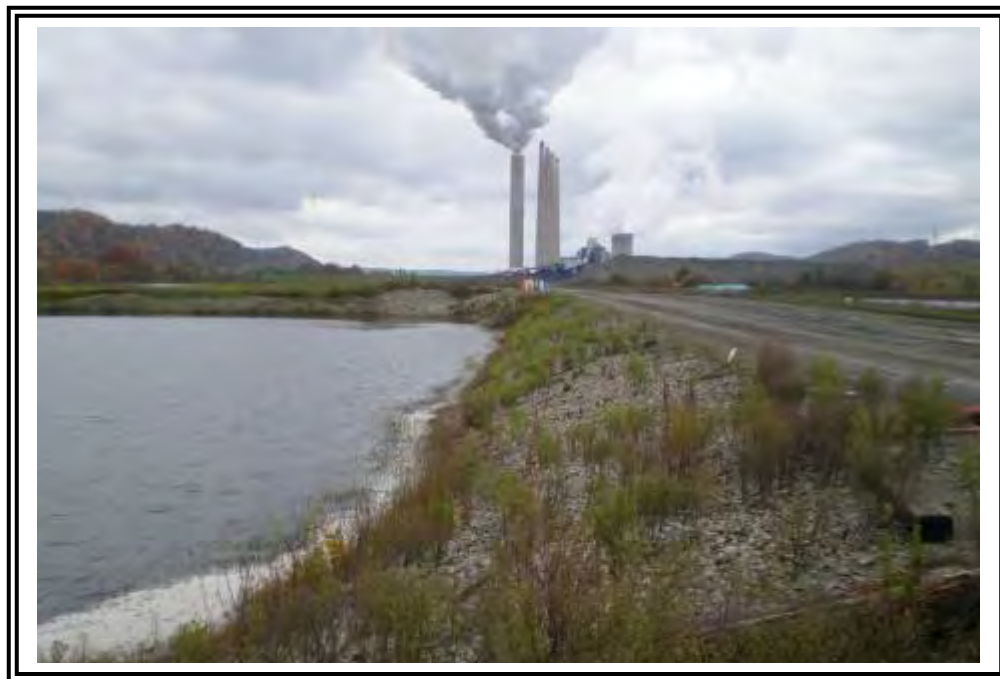
96

Looking west along the Pond 7/7A north dike upstream slope impounding Pond 7A.
Note gravel slope surface and freeboard at this location of the dike.

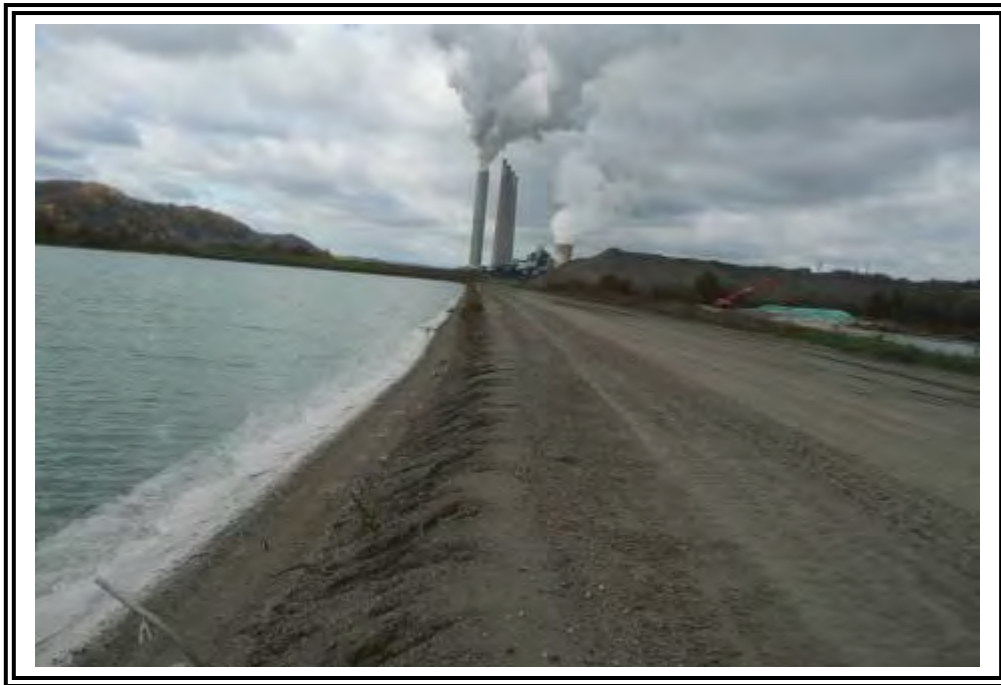
97

Looking west along the separator dike between Pond 7 (left) and Pond 6 (right).

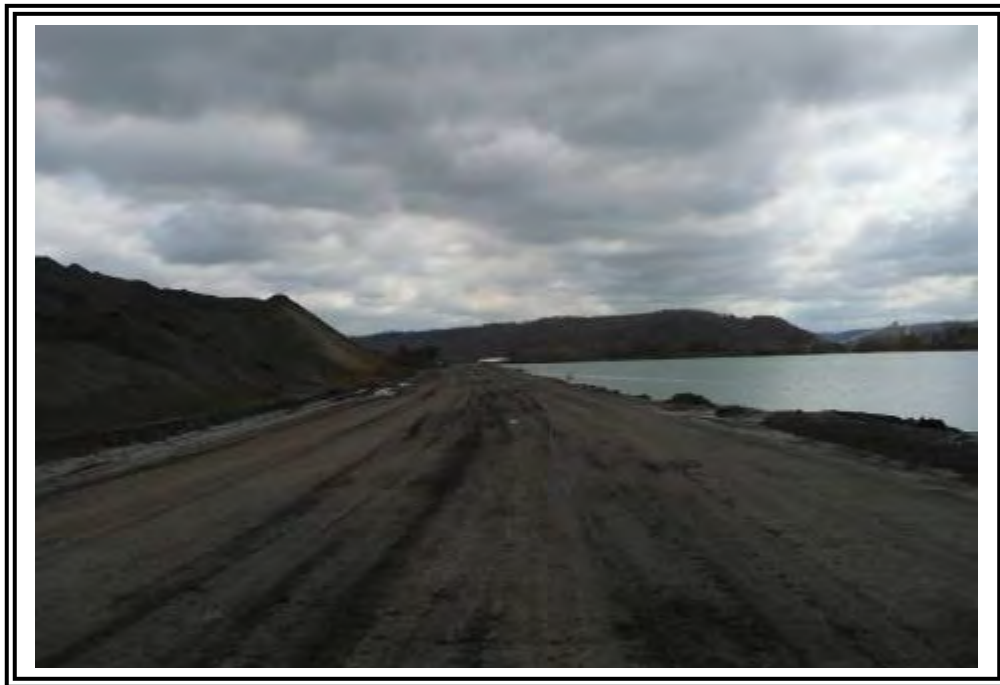
100

Pond 6 and Pond 7/A separator dike looking east showing open water in Pond 7/A on right and ash processing in Pond 6 on left.
